# 27. BEACH BOULEVARD SEAWALL

City of Pacifica

## VULNERABILITY SUMMARY

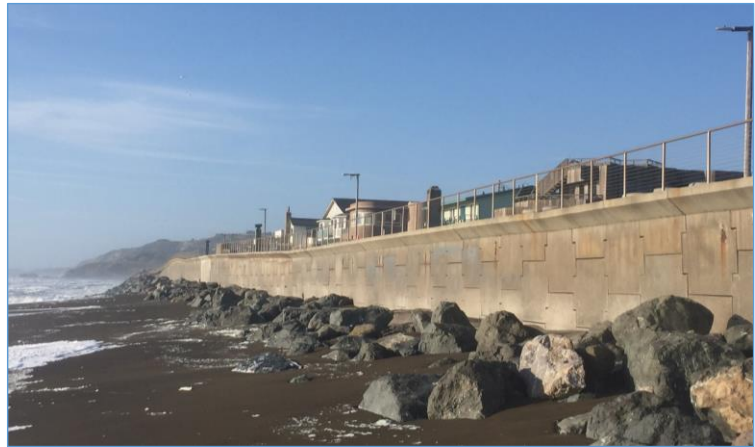
The Seawall functions, particularly the northern section, are very sensitive to seawall breaching, as the Seawall is the only line of defense for this area. The northern section was built in 1984 as a retaining wall rather than an engineered seawall. It is built on loose fill and is particularly vulnerable to wave action and erosion. In 2016, a breach caused a portion of northern Beach Boulevard and the pedestrian promenade to be closed for roughly six months. The southern section, built in 1987 using a more robust method, has never experienced a breach.

Beach Boulevard seawall from the beach, looking north.

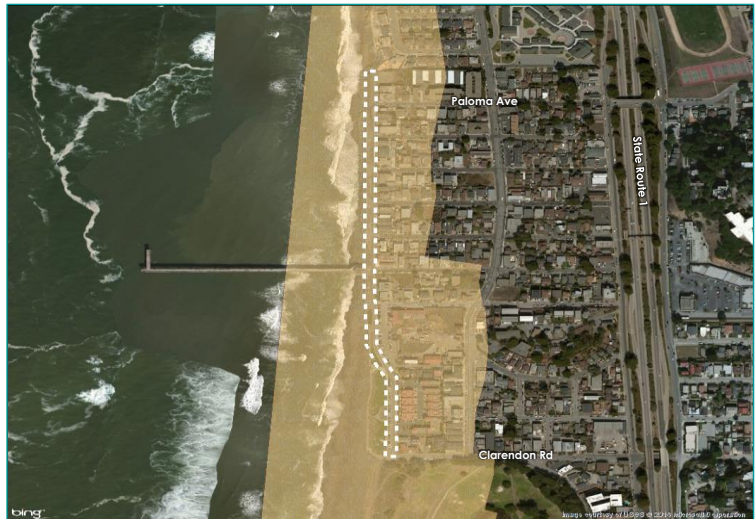
The Seawall is located within the area identified in the Pacific Institute study (2012) as susceptible to erosion (eastern extent by 2100 in yellow). The area of erosion concern, as illustrated, could occur by 2100 if the Seawall were breached, if the northern section is not upgraded, and if all shore line protections were not adequately maintained. The City of Pacifica is repairing the recent damage and pursuing grant opportunities to replace the entire northern section of the Seawall.

Erosion Analysis: Site is entirely in future erosion area.

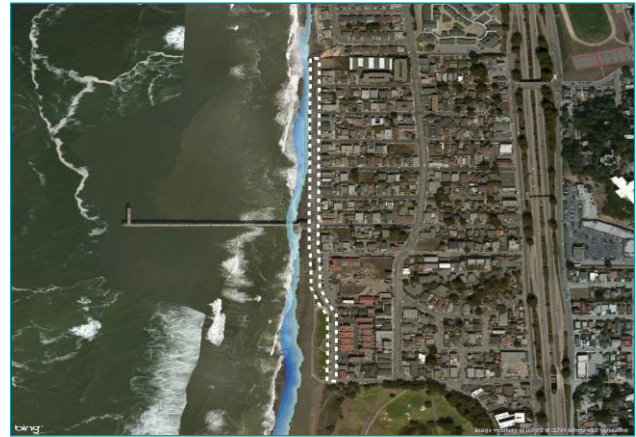
**Baseline Scenario:** Asset not yet inundated.

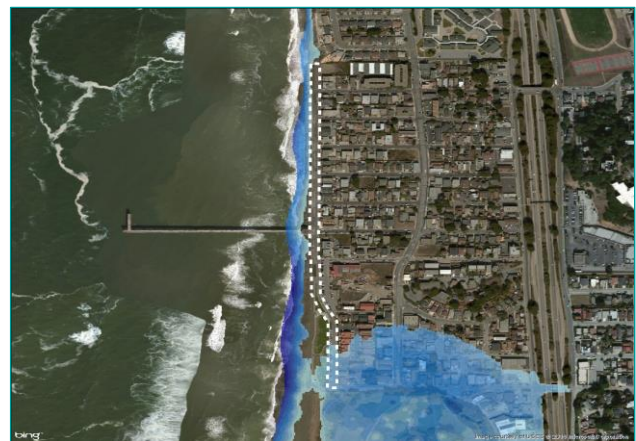
**Mid-Level Scenario:** Asset under 0 to 5 feet of water.

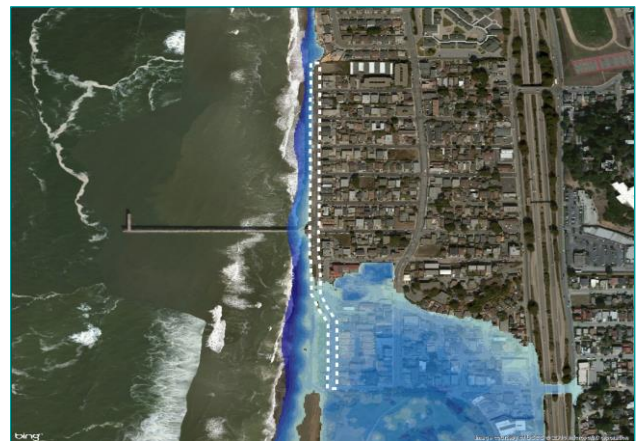
**High-End Scenario:** Extensive flooding behind asset.

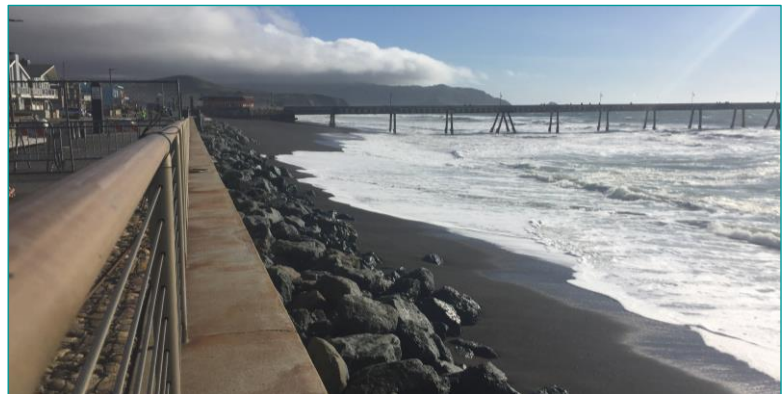
Beach Boulevard Seawall, looking south.

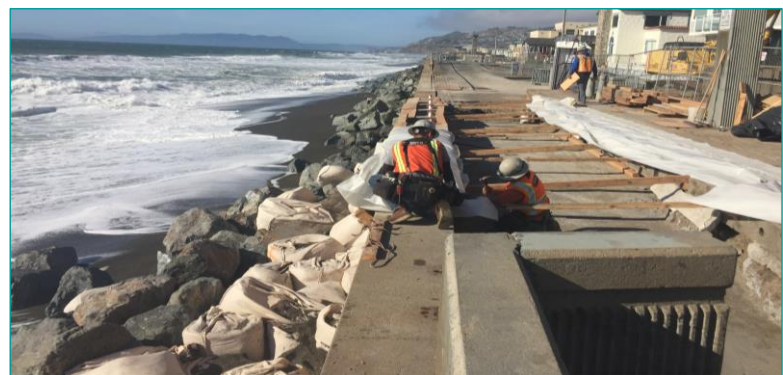
The Seawall is highly exposed and is regularly subject to high tides and wave action under current conditions. The northern section of the Seawall has experienced breaches in 2002, 2006, and 2016 when exceptionally high tides combined with high swells and waves crashed into and over the Seawall. The rock revetment adjacent to the northern Seawall also regularly loses rocks due to wave action. The southern section has sustained no damage since construction in 1987. Sea level rise will increase the exposure of both Seawall sections, as higher mean water levels will lead to more frequent overflow, and deeper water will allow larger waves to reach and damage the Seawall. This combination will put the Seawall further at risk of overtopping and erosion damage and endanger city infrastructure, utilities, houses, and other properties it protects. Historical erosion data and projected future erosion (USGS, Pacific Institute) indicate that this asset, and the surrounding area, are particularly likely to experience severe erosion by 2100. For more detail on the Seawall construction and an overtopping analysis of the southern Seawall, refer to the *Coastal Hazards Study 2212 Beach Boulevard, Pacifica: Technical Report with Executive Summary* (City of Pacifica 2016).

Repairs being performed on the Seawall after the 2016 breach.
