7. HALF MOON BAY LANDFILL

County of San Mateo

VULNERABILITY SUMMARY

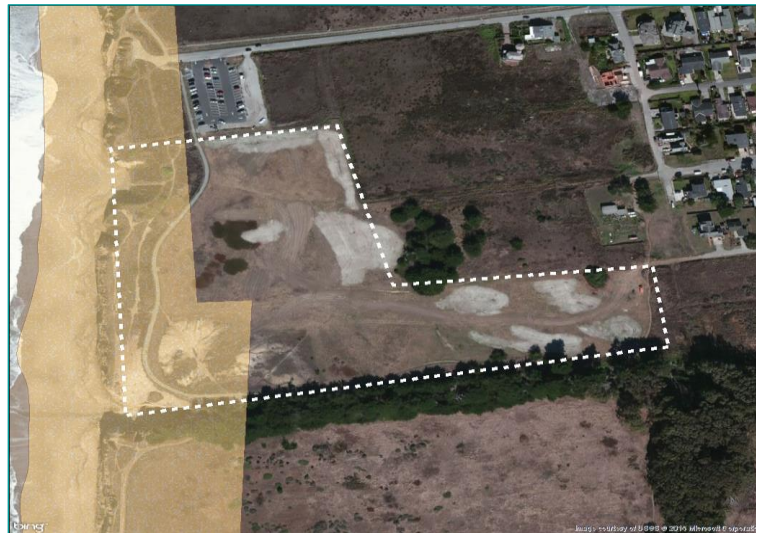
The western edge of the Landfill is located within the area identified by the Pacific Institute study (2012) as susceptible to erosion by the year 2100. The yellow band (see map on the right) represents the eastern extent of erosion that can be expected. The site is located near a residential neighborhood as shown in the photo.

Western edge of landfill within future erosion extent.

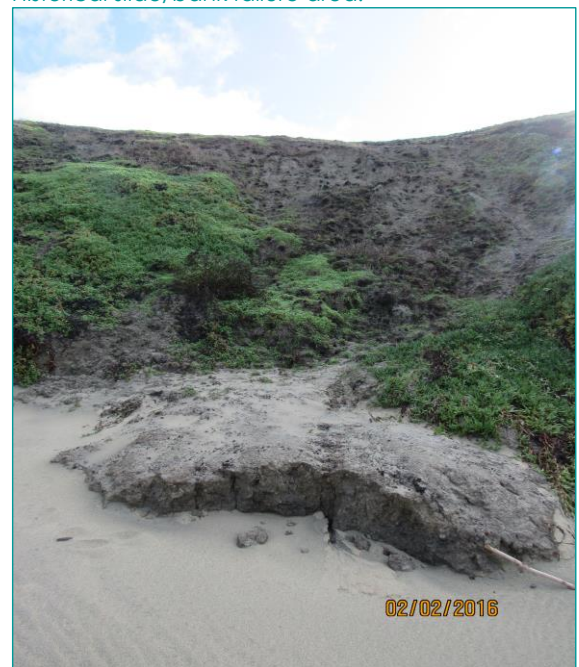
The site is highly exposed to coastal erosion and wave action, and the most recent significant erosion occurred in 2010. Waves in the early 1990s also eroded portions of the marine terrace, exposing the Landfill along the cliff face, which warranted repairs and regrading, including the installation of a concrete block steel chain mat revetment on the slope to reduce future erosion.

Historical slide/bank failure area.

Adaptive capacity of the asset is moderate, as there is some ability to protect against erosion; for example, the County built a concrete block steel chain mat revetment on the slope to protect the Landfill from wave erosion and scour, and to minimize the likelihood that waste could be exposed. Furthermore, County staff engage in regular monitoring of the site and its revetment to minimize the potential for future erosion, waste exposure, and pollutant leaching. The recreational uses of the site have a high adaptive capacity because, if waste were exposed or a section of the trail eroded, visitors could still use the site (after waste removal) and take an alternate path set farther back from the cliff.

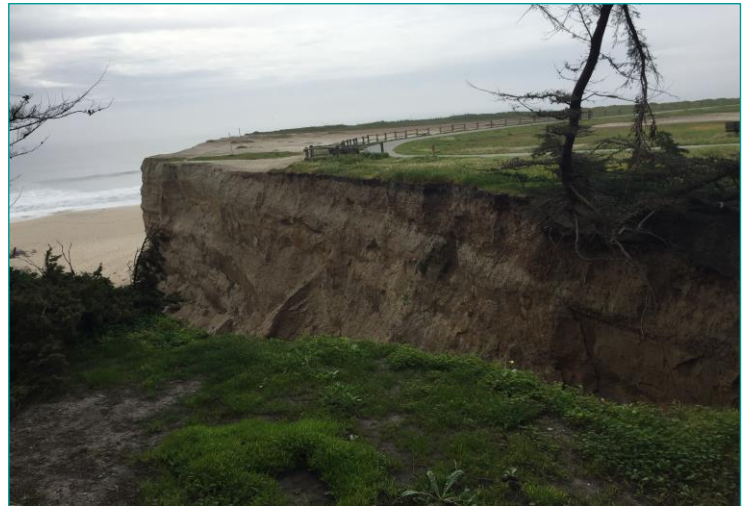
It is likely that the inland extent of erosion into the Landfill will increase with sea level rise, especially in areas where there is already erosion and headcutting, such as at the southern drainage outlet which is migrating upstream at a rate of 7-10 feet per year.

Headcut and severe erosion at southern drainage outlet.

In the near-term, it may be necessary to reinforce and enhance the seawall protecting the asset and preserving its recreational benefits. In the long-term, however, it may make more sense to perform a clean closure, and relocate the waste away from a vulnerable area (for example, to Ox Mountain). The land could then be returned to a county Park, and this segment of the CCT could be relocated inland if needed.

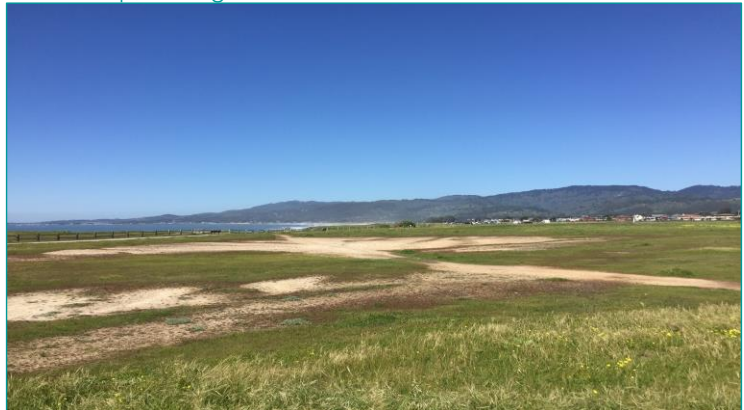
Landfill cap, looking west.
