# 27. BEACH BOULEVARD SEAWALL

City of Pacifica

## VULNERABILITY SUMMARY

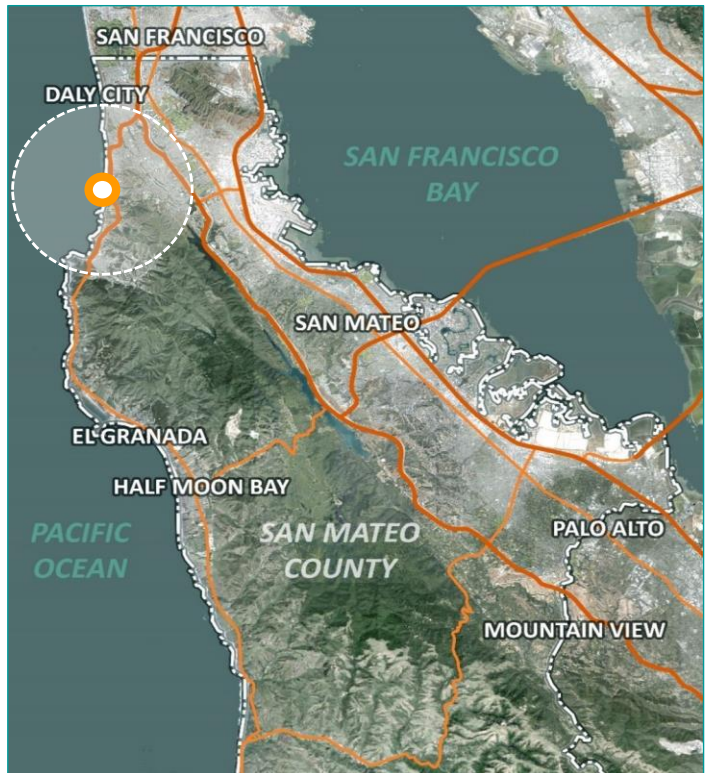
The Seawall functions, particularly the northern section, are very sensitive to seawall breaching, as the Seawall is the only line of defense for this area. The northern section was built in 1984 as a retaining wall rather than an engineered seawall. It is built on loose fill and is particularly vulnerable to wave action and erosion. In 2016, a breach caused a portion of northern Beach Boulevard and the pedestrian promenade to be closed for roughly six months. The southern section, built in 1987 using a more robust method, has never experienced a breach.

Beach Boulevard seawall from the beach, looking north.
